Detailed Structural Assessment  
Southern Nevada Health District Main Building  
Las Vegas, NV

Prepared for  
PGAL, Inc.

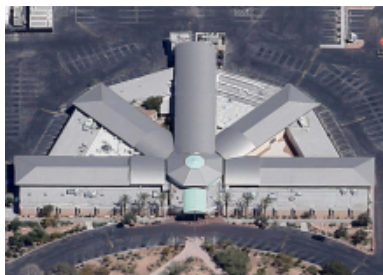
Photo 1 - PHC Main Building Aerial View

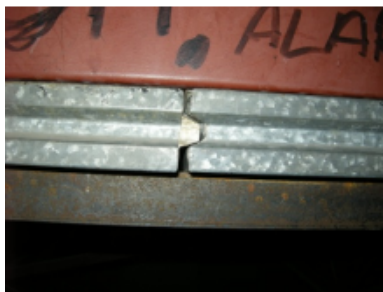
Photo 2 - Joint between Roof Panels

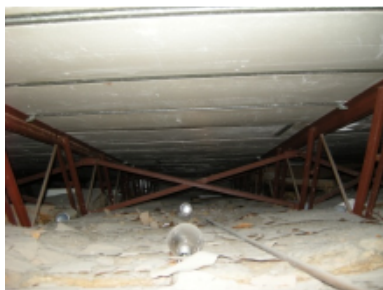
Photo 3 - Gypsum Panel Roof

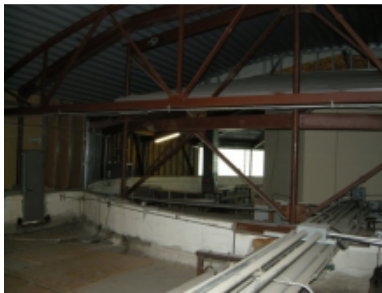
Photo 4 – Underneath over-framed roof

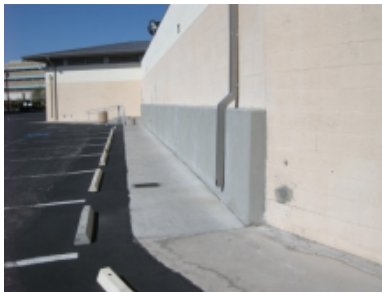
Photo 5 – Concrete buttress wall

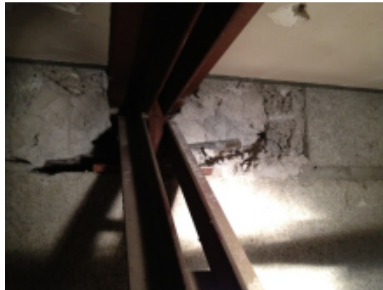
Photo 6 – Steel joist seat.

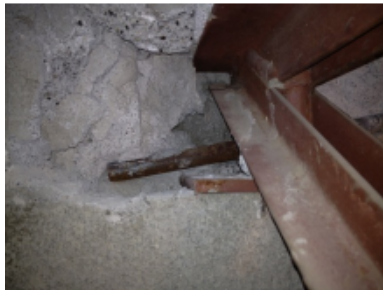
Photo 7 – Close up of the joist seat.

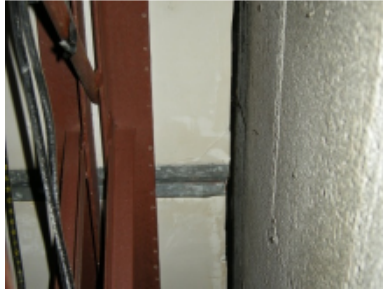
Photo 8 – Gap between the roof panels and the masonry wall.

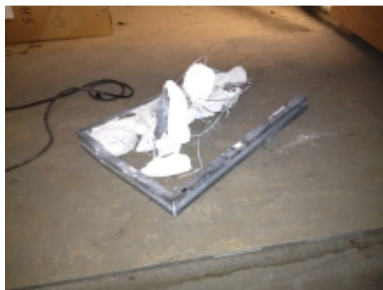
Photo 11 – Metal edged USG gypsum roof panel.

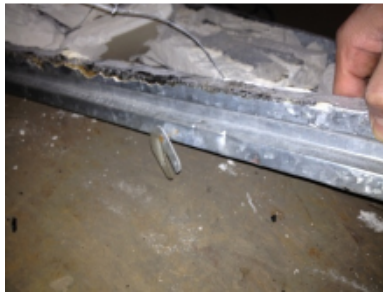
Photo 12 – A section of metal edged roof panel with attachment clip.

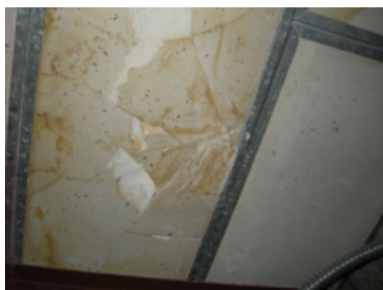
Photo 16 – Fractured gypsum roof panel.

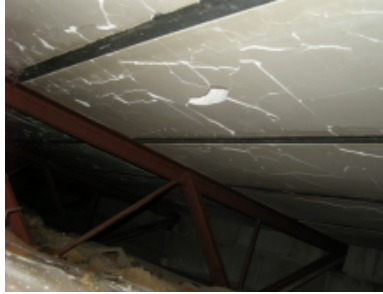
Photo 17 – Gypsum roof panels showing major fractures.

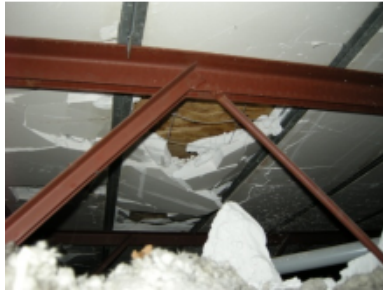
Photo 18 – Failed roof panel.

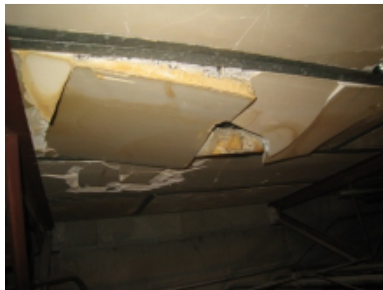
Photo 19 – Failed roof panel.

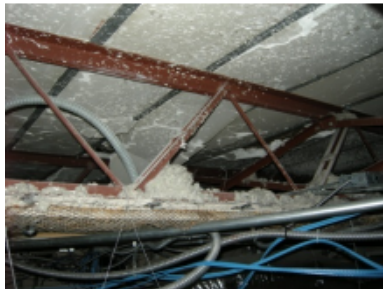
Photo 20 – Failed roof panel.

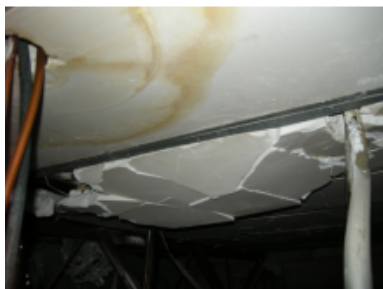
Photo 21 – Failed roof panel.

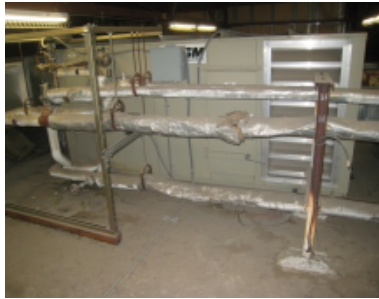
Photo 22 – Typical rooftop mechanical unit.

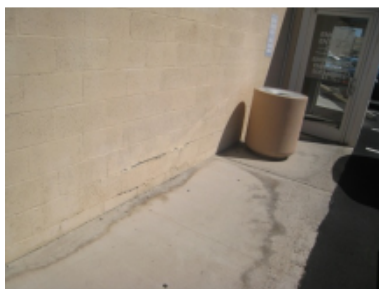
Photo 25 – Wall fracture.

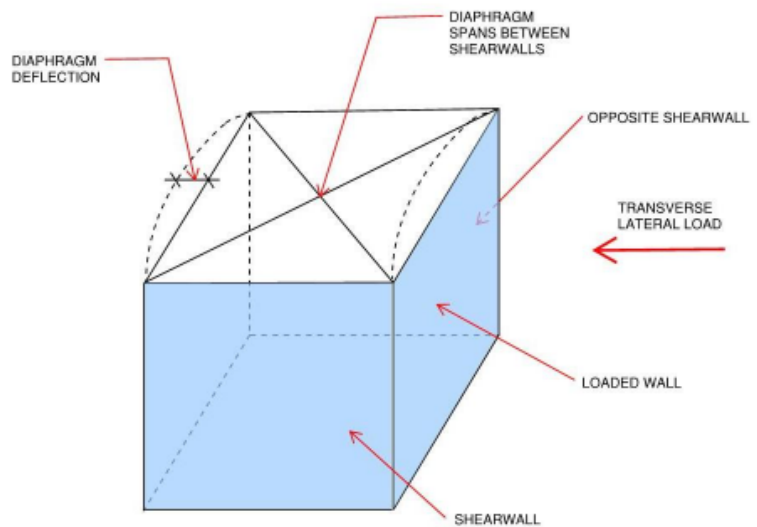
Diagram 1 – Elements of a lateral force resisting system

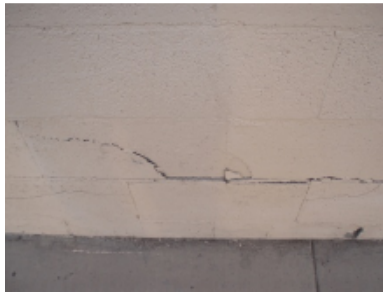
Photo 26 – Fracture at wall base.

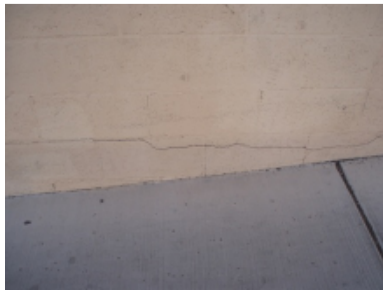
Photo 27 – Fracture at wall base.

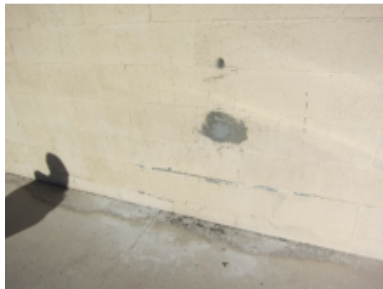
Photo 28 – Fracture at wall base.

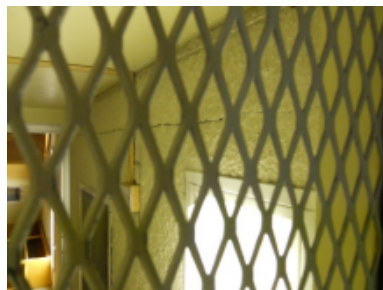
Photo 29 – Fracture on the interior side of an exterior wall.

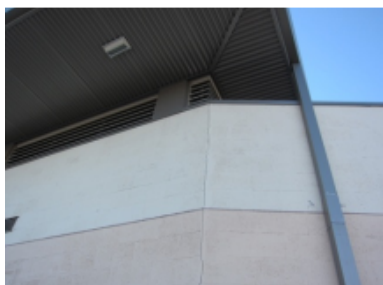
Photo 30 – Cracked formed at intersecting walls.

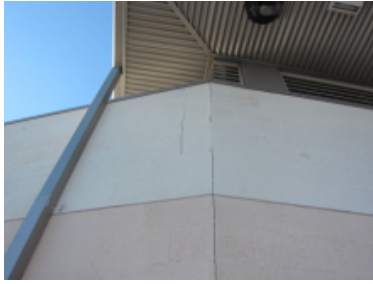
Photo 31 – Cracked at joint of intersecting walls.

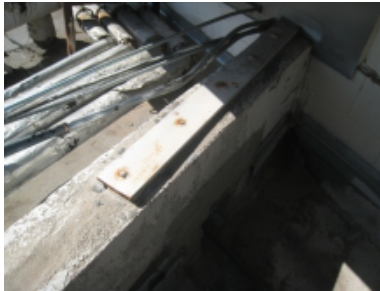
Photo 32 – Corroded lateral attachment.

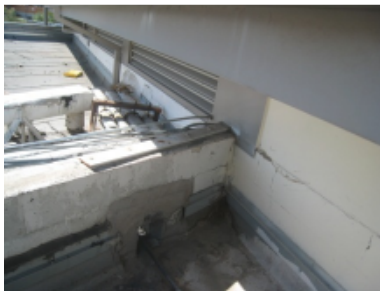
Photo 33 – Corroded lateral attachment.

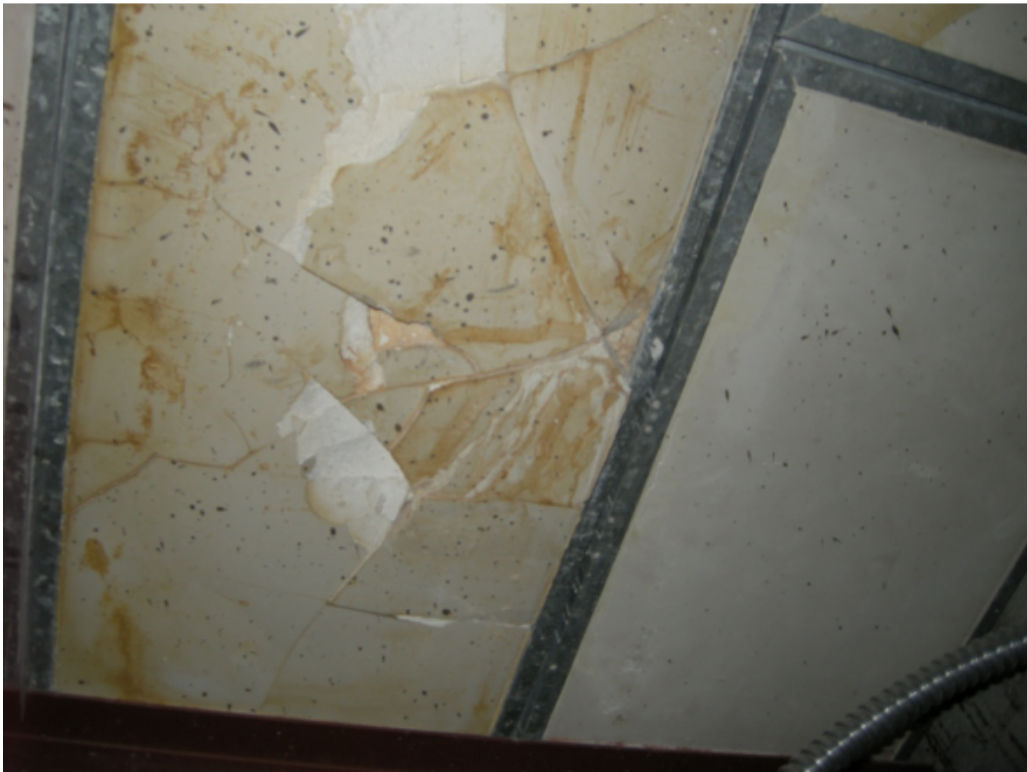
Photo 16 – Fractured gypsum roof panel.

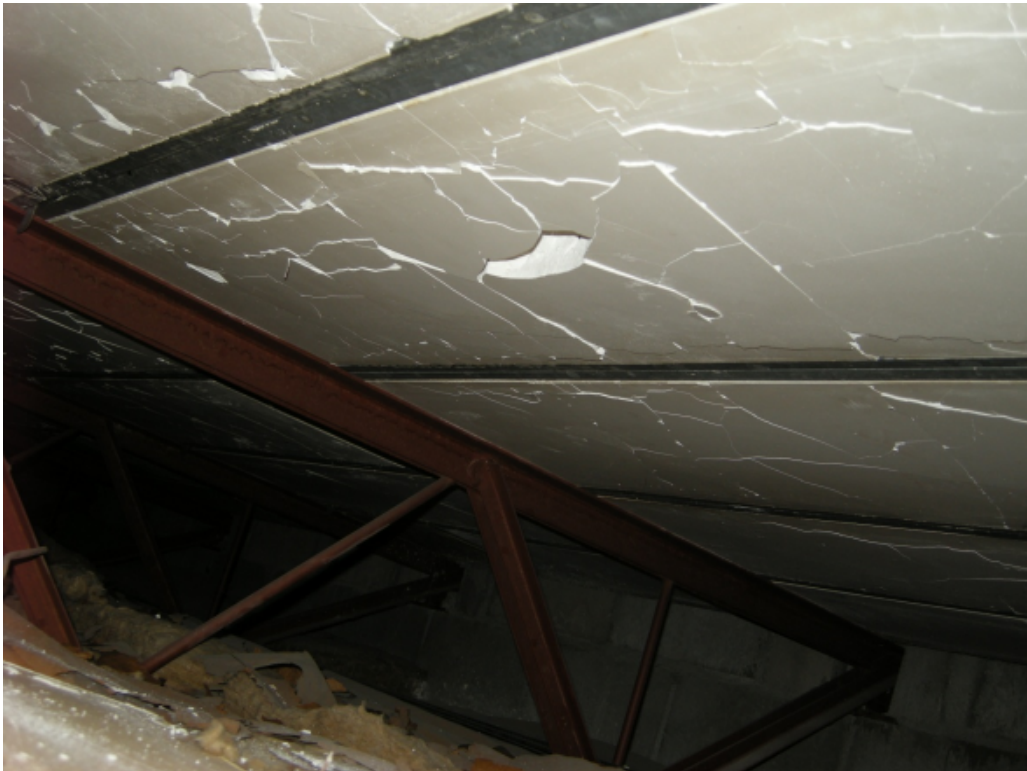
Photo 17 – Gypsum roof panels showing major fractures.

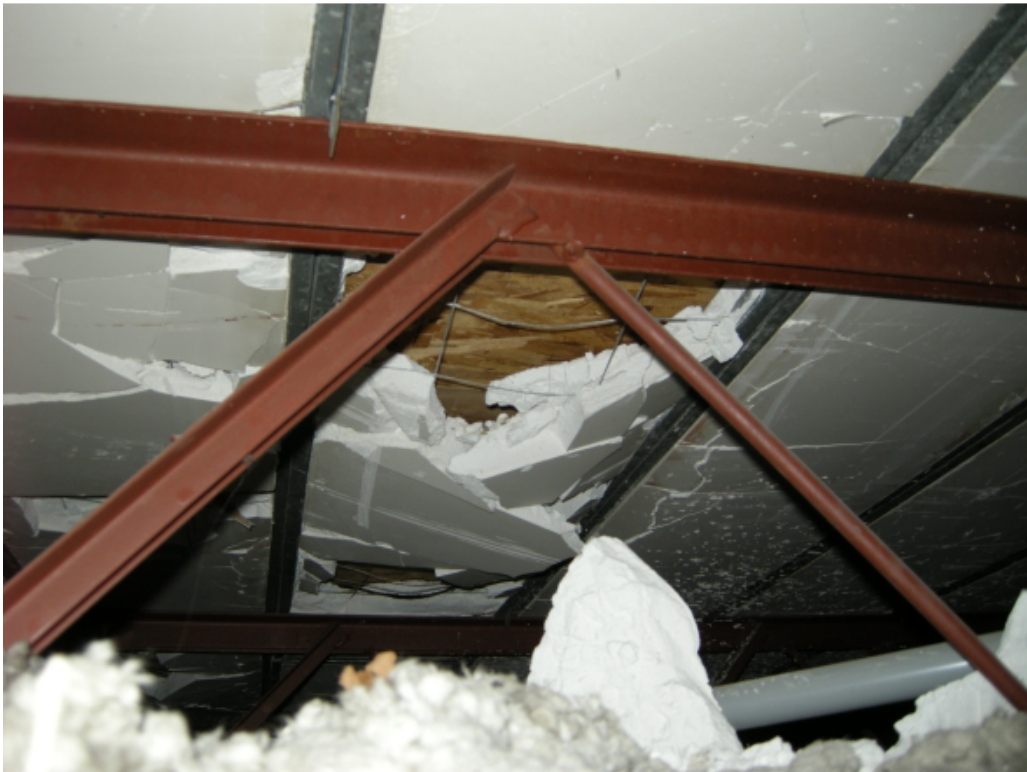
Photo 18 – Failed roof panel.

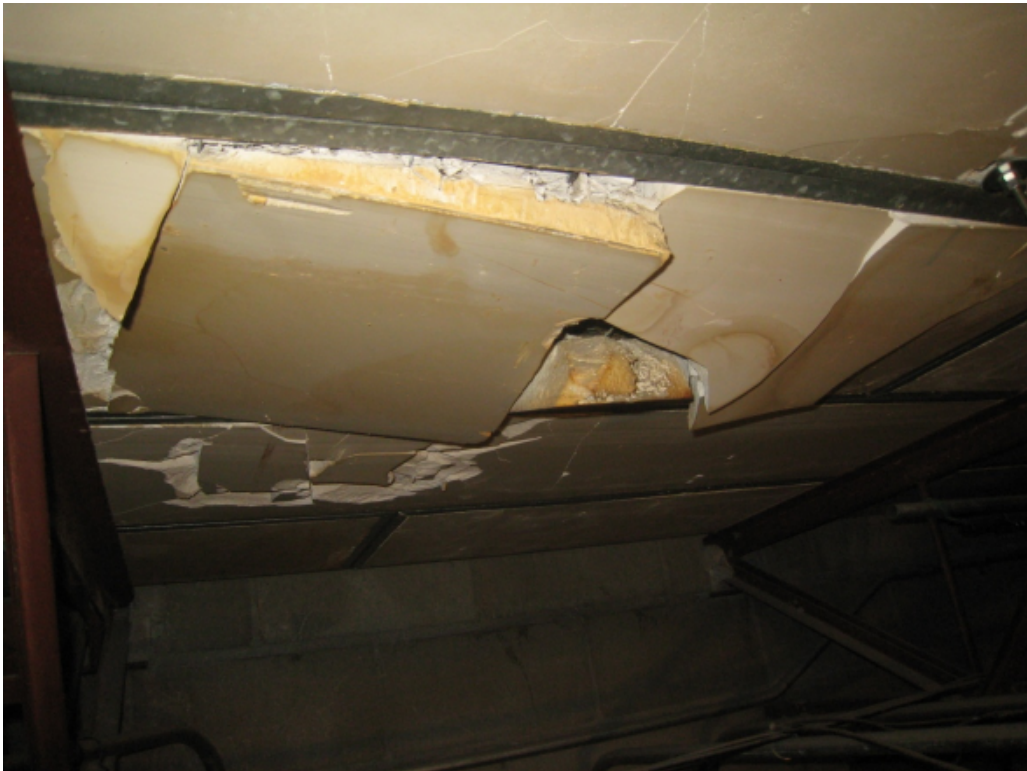
Photo 19 – Failed roof panel.

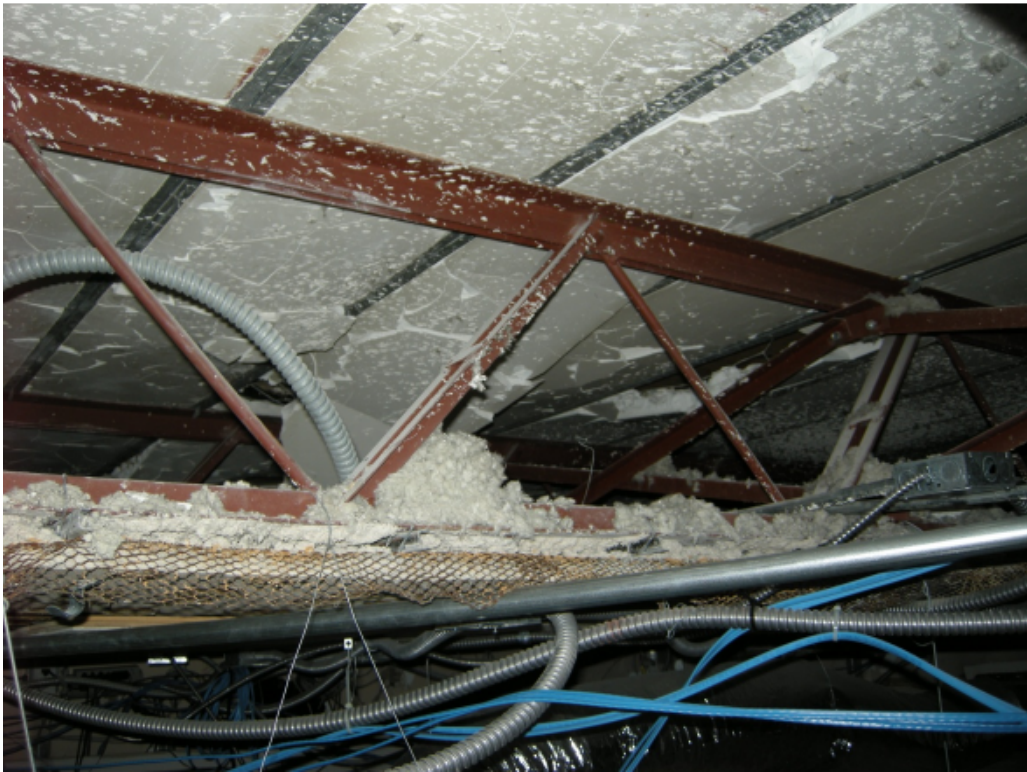
Photo 20 – Failed roof panel.

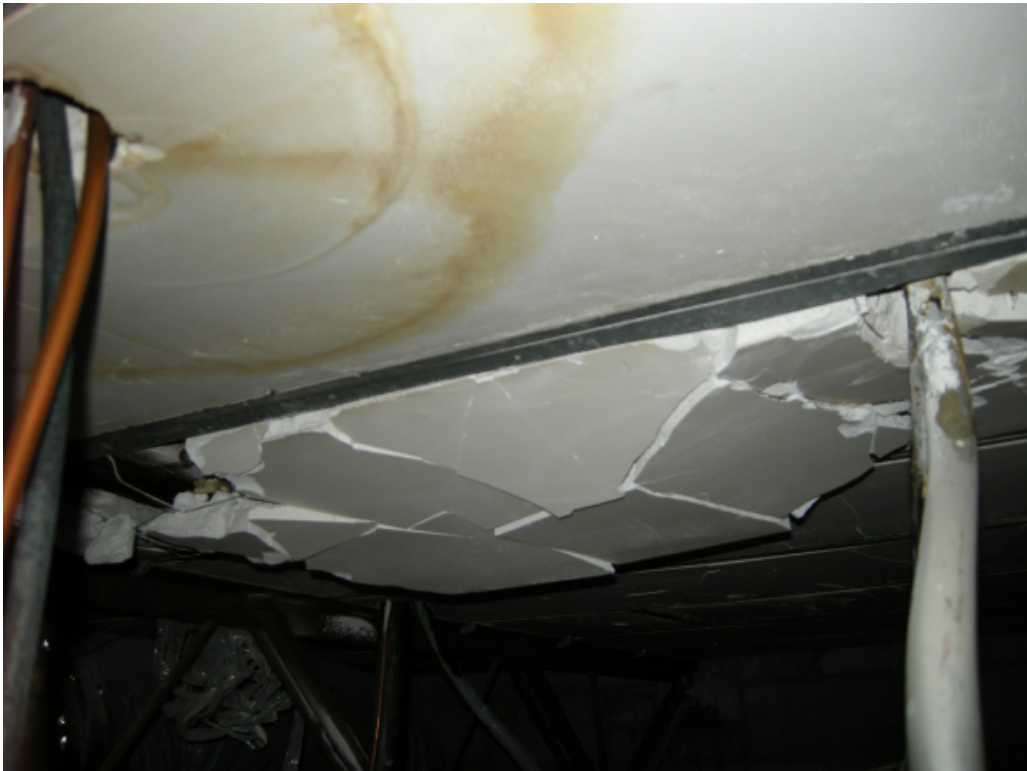
Photo 21 – Failed roof panel.

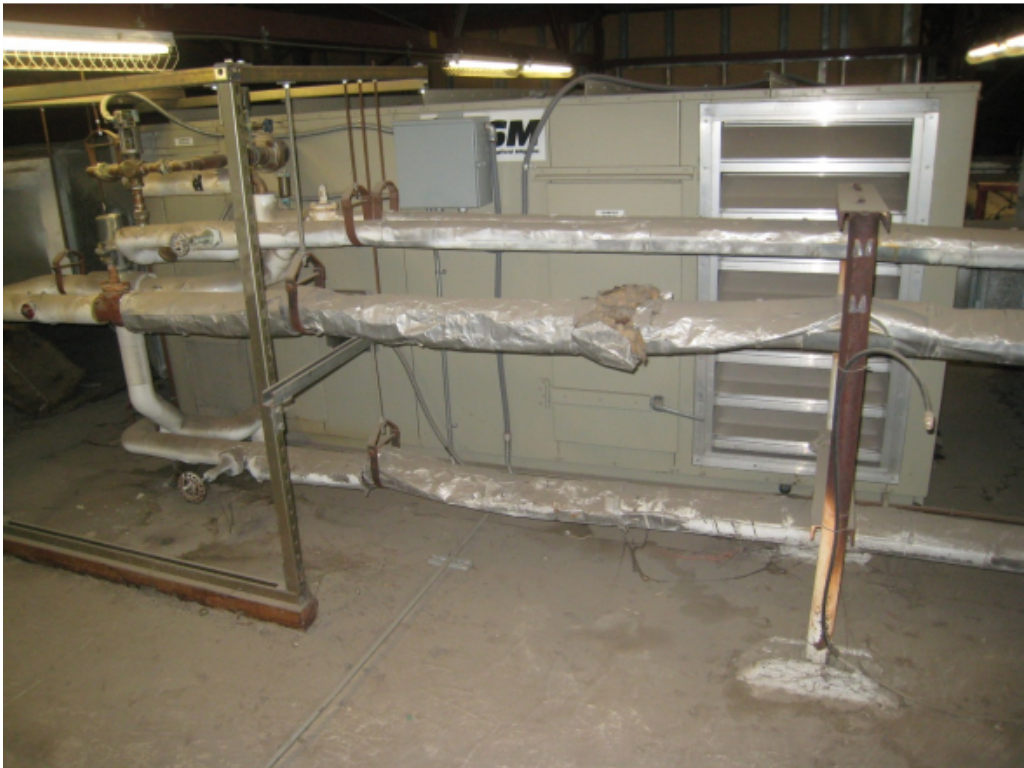
Photo 22 – Typical rooftop mechanical unit.

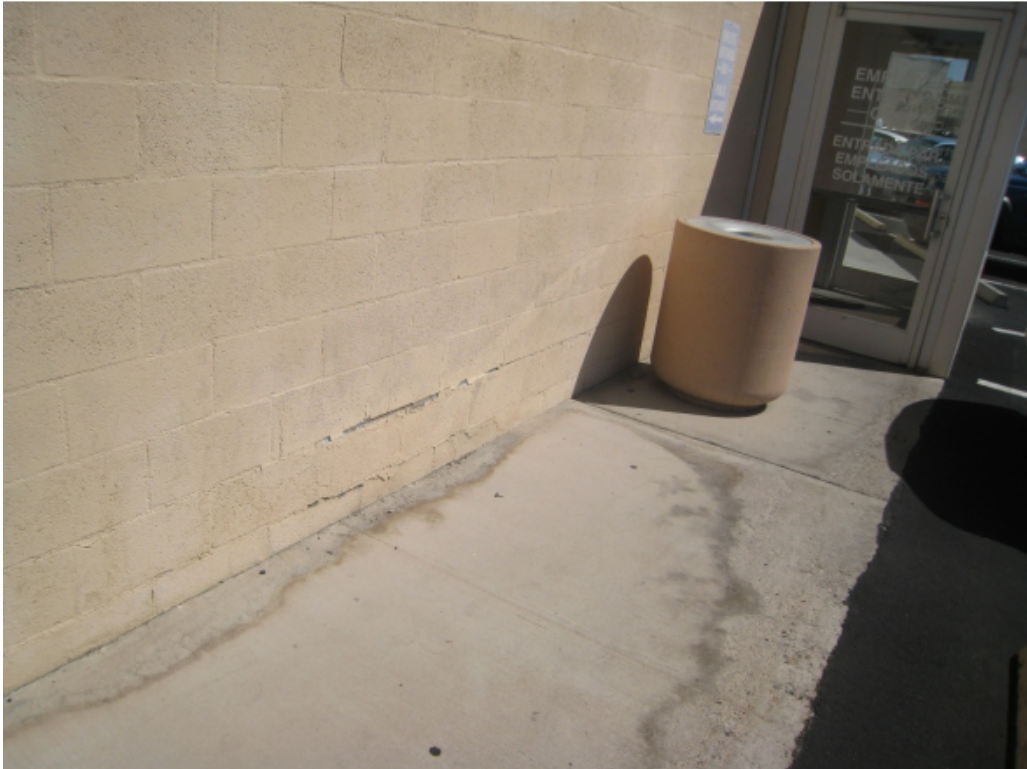
Photo 25 – Wall fracture.

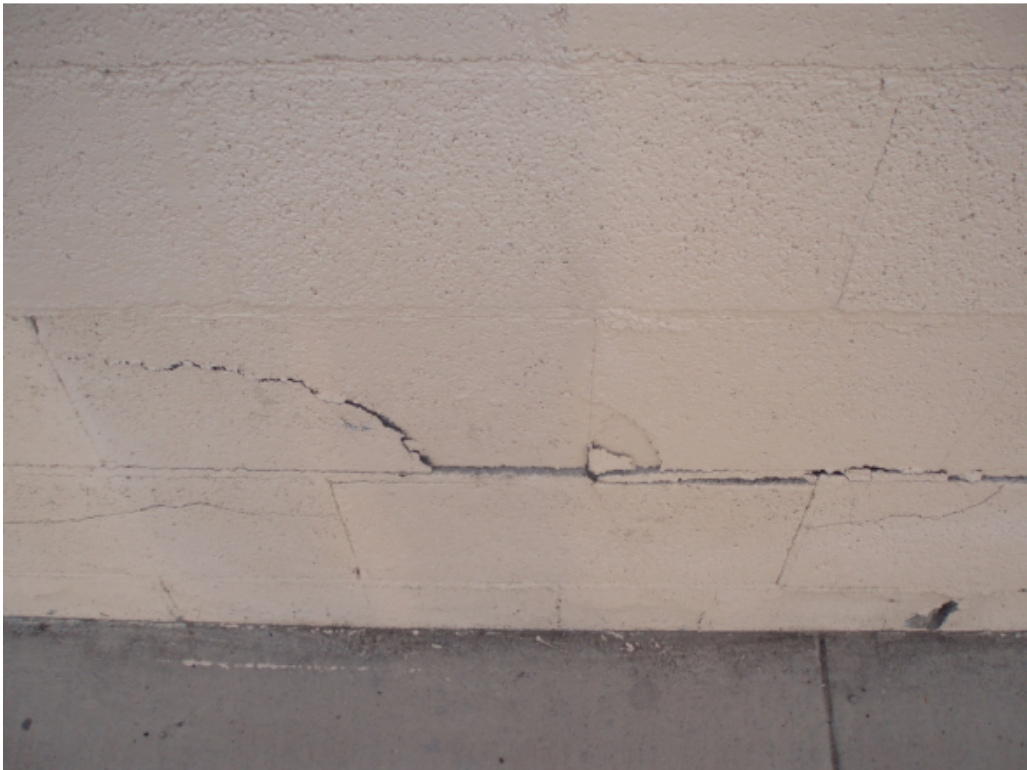
Photo 26 – Fracture at wall base.

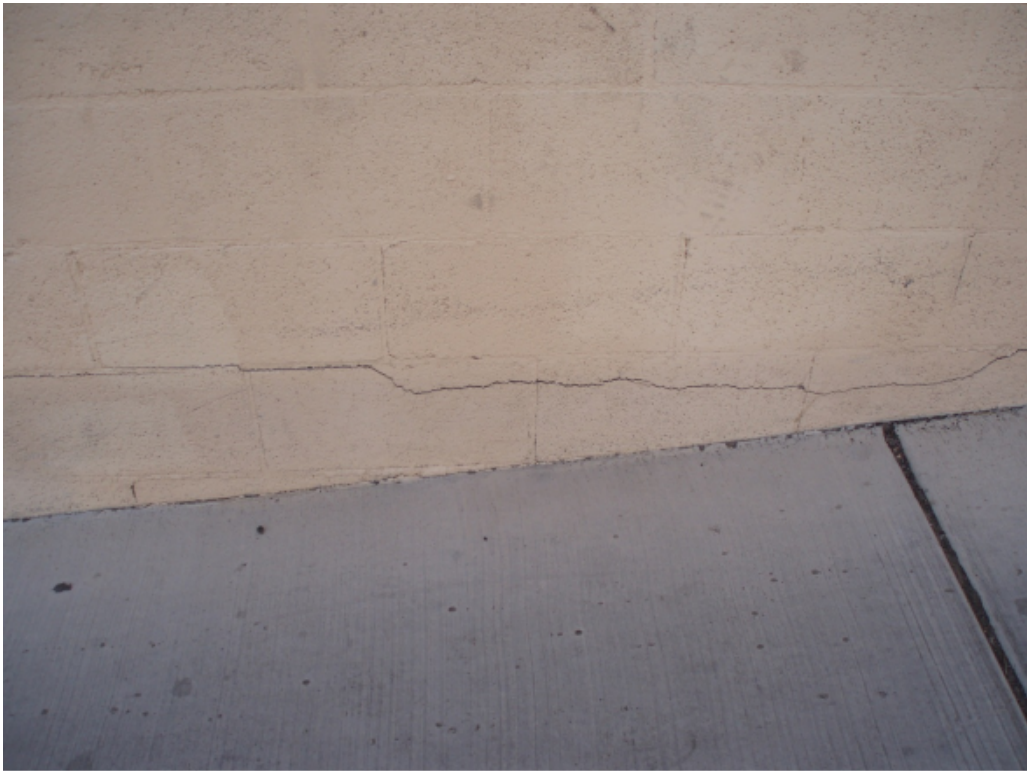
Photo 27 – Fracture at wall base.

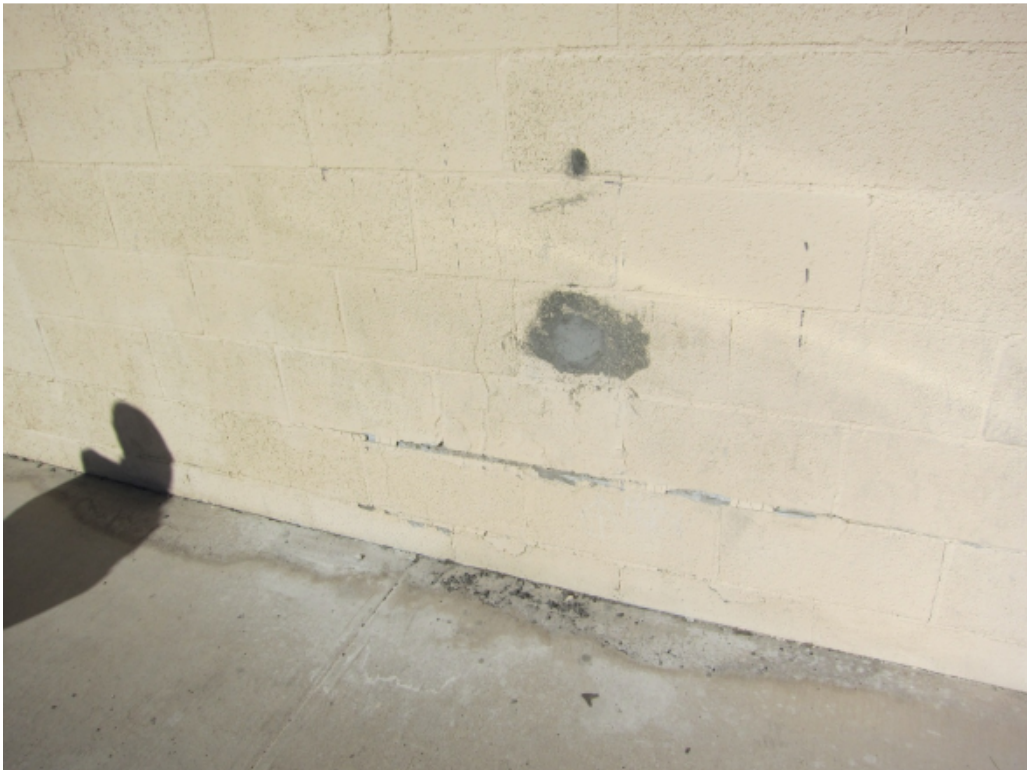
Photo 28 – Fracture at wall base.

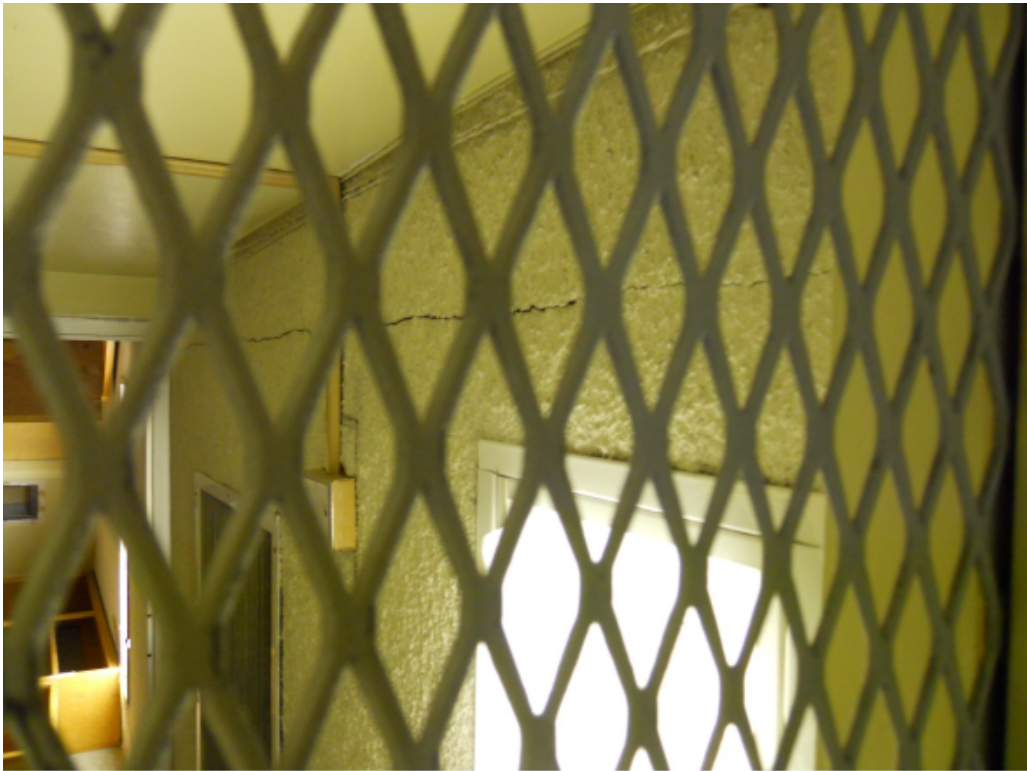
Photo 29 – Fracture on the interior side of an exterior wall.

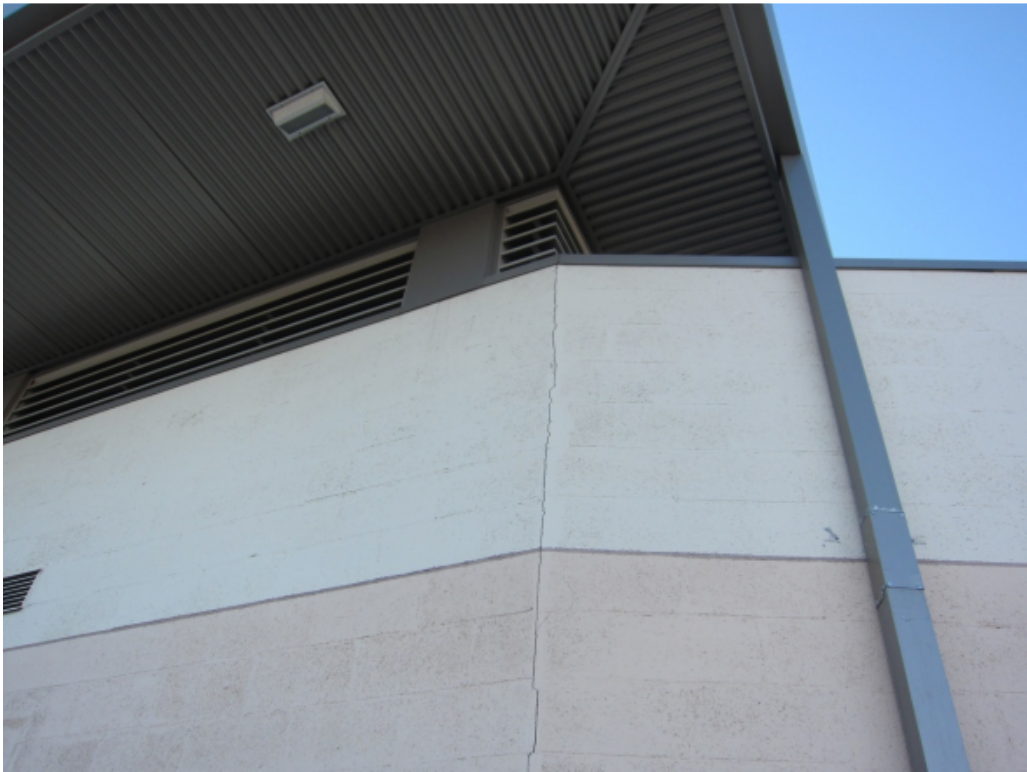
Photo 30 – Cracked formed at intersecting walls.

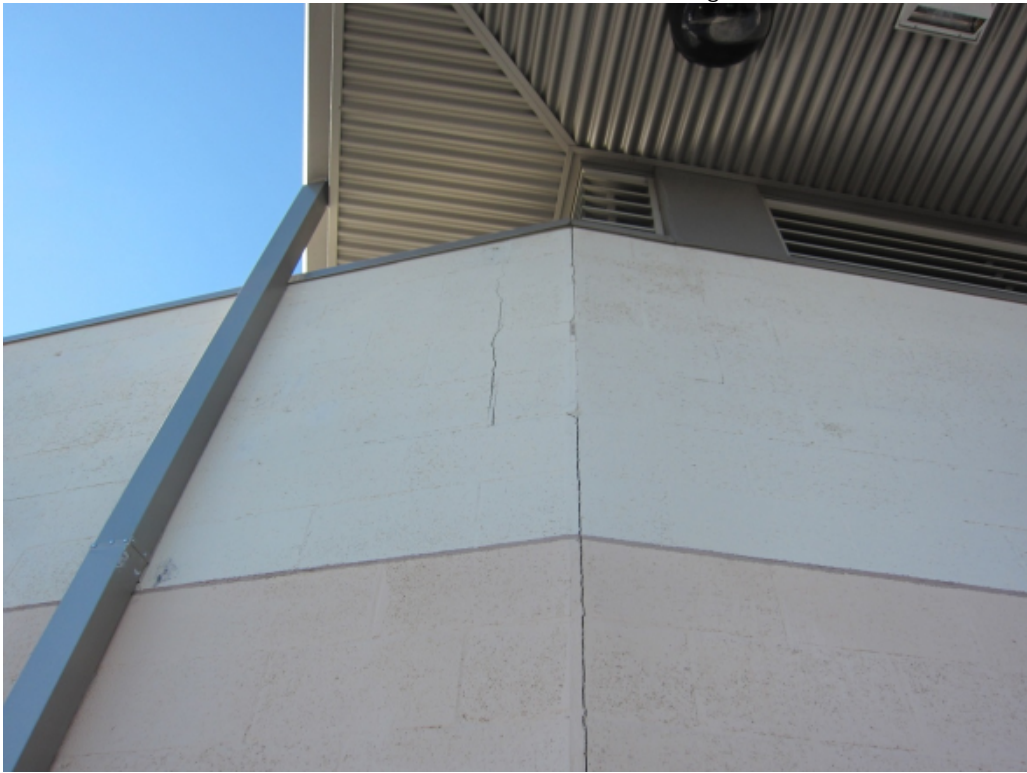
Photo 31 – Cracked at joint of intersecting walls.

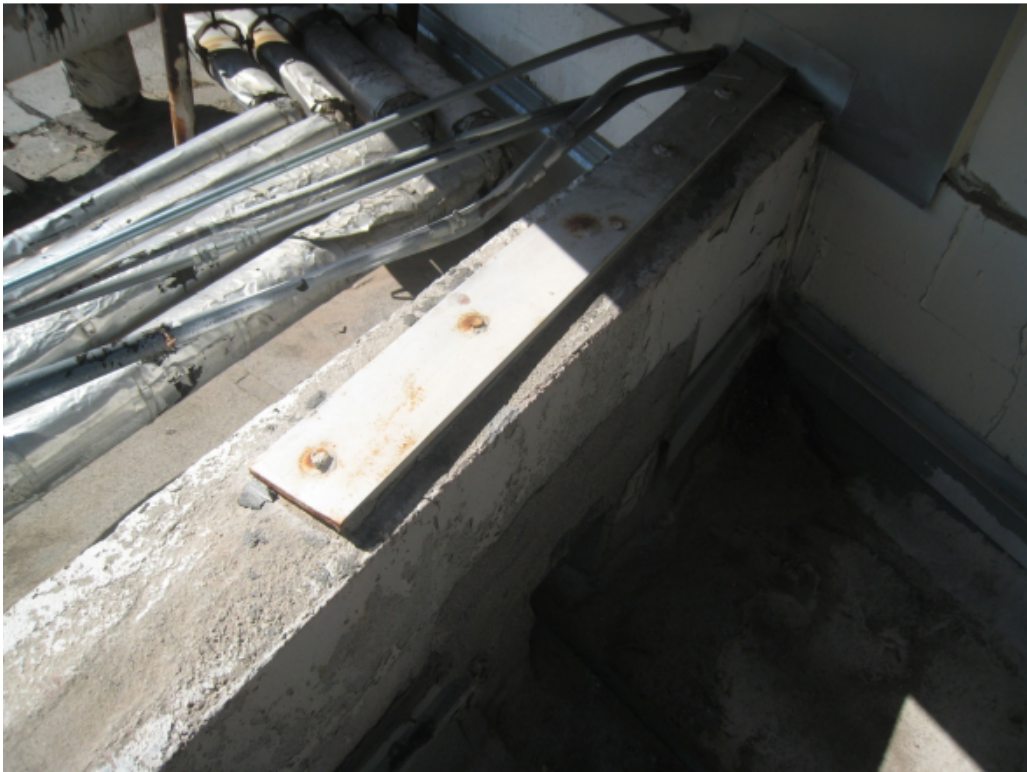
Photo 32 – Corroded lateral attachment.

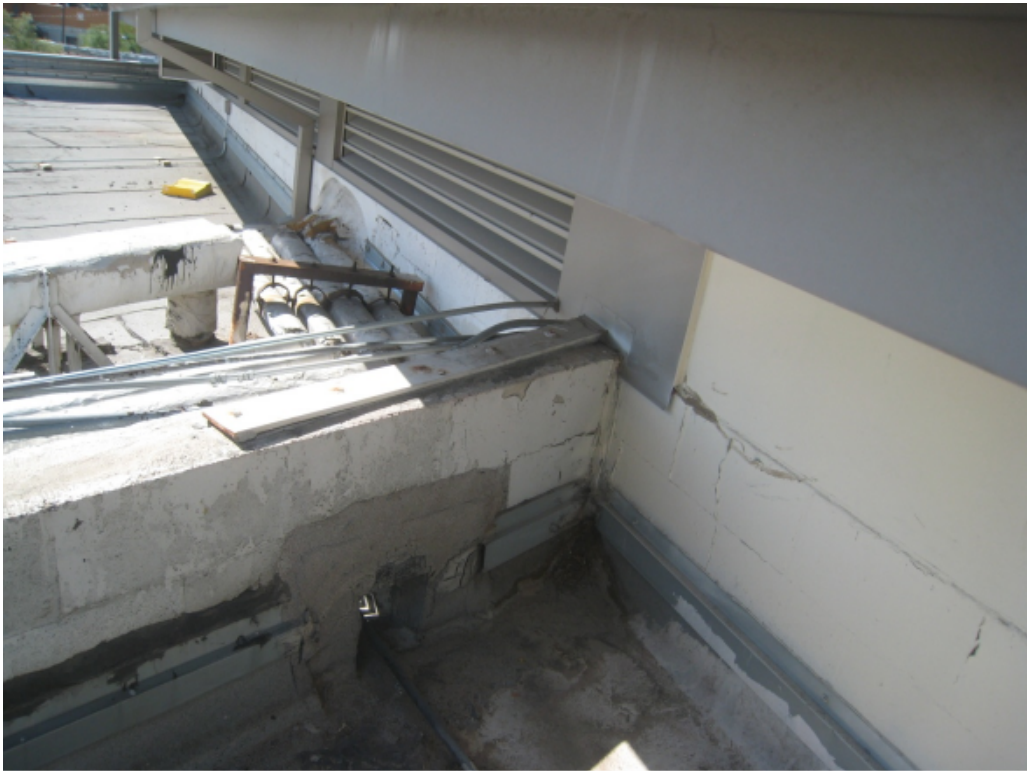
Photo 33 – Corroded lateral attachment.
