# Aquatic Health Plan Approval: Speed Bumps and Changes

Candice Konold, Senior Environmental Health Specialist  
Southern Nevada Health District  
February 24, 2022

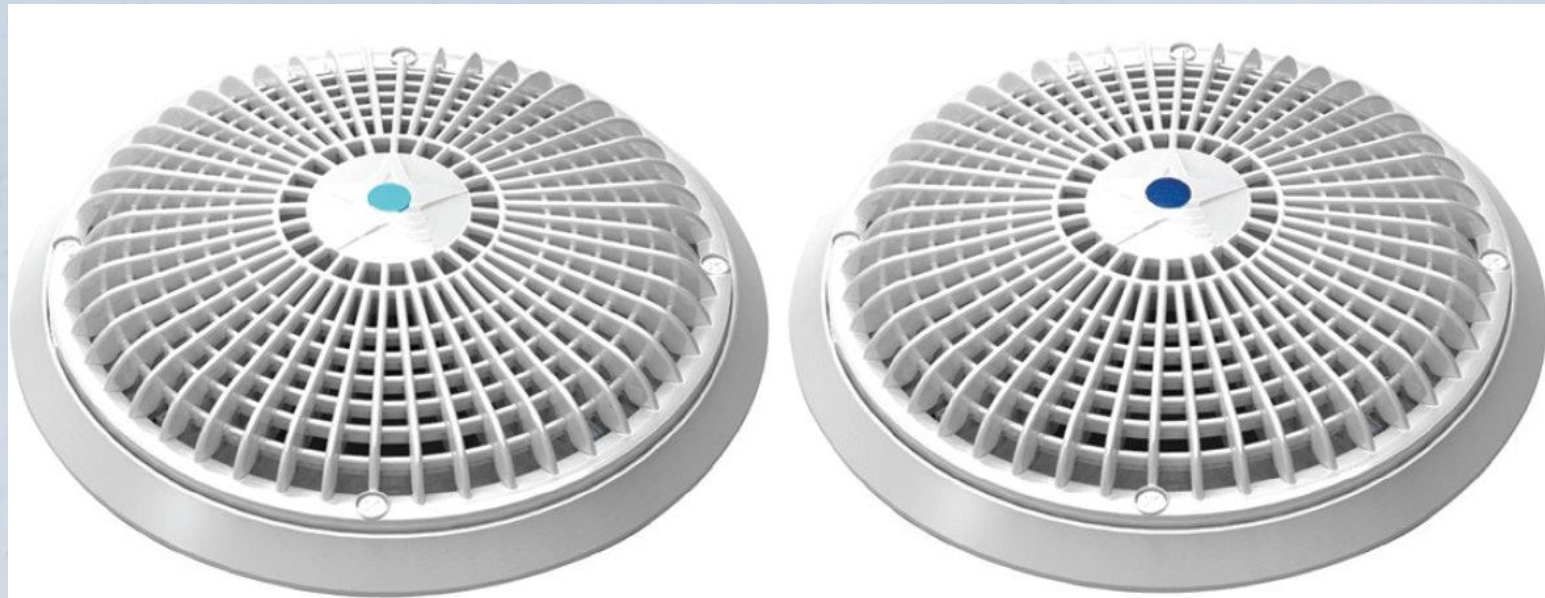
Drain Covers

vs.

Suction Outlet Fitting Assemblies (SOFAs):  
What's the dif???

- The American National Standard for Suction Outlet Fitting Assemblies for Use in Pools, Spas, and Hot Tubs (ANSI/APSP/ICC-16 2017)
    - New testing procedures have resulted in different **flow rates** and **sump** and **pipe** requirements for existing cover designs
    - SOFAs manufactured after May 24, 2021 must conform to the new standard
  - Labeling
    - “Old” drain covers are embossed with ASME/ANSI A112.19.8 (2007, 2008a, or 2009b), ANSI/APSP-16 2011, or VGB 2008
    - “New” SOFAs are embossed with VGBA 2017 and a manufactured date after May 24, 2021
